EGR Valves 88259R/ 88260R/ 88271R

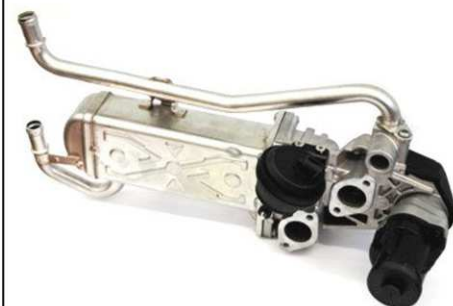
88260R

A problem related to these valve models is that the position signal remains in error, despite the fact that the adaptation procedure may have been performed correctly. This issue is mainly noticed on 1.6 TDI engines.

- 1) Connect the diagnostic tool to the OBD and start the vehicle.
- 2) Keep the engine at idle speed until it reaches the optimum operating temperature, usually that is when the Fan intervenes.
- 3) With the engine heated proceed to clear the error.
- 4) The error code from that moment should no longer be present.
