EGR Valves 7518259R/ 7518260R/ 7518271R

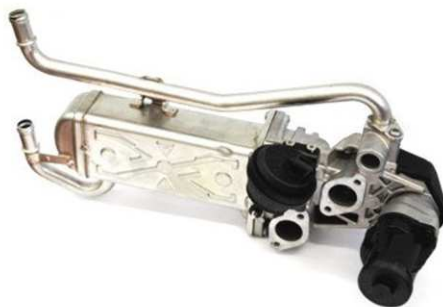
7518260R

A problem related to these valve models is that the position signal remains in error, despite the fact that the adaptation procedure may have been performed correctly. This issue is mainly noticed on 1.6 TDI engines.

- 1) Connect the diagnostic tool to the OBD and start the vehicle.
- 2) Keep the engine at idle speed until it reaches the optimum operating temperature, usually that is when the Fan intervenes.
- 3) With the engine heated proceed to clear the error.
- 4) The error code from that moment should no longer be present.
