Complaints about codes 7506984, 7506985, 7507208 and 7507209.

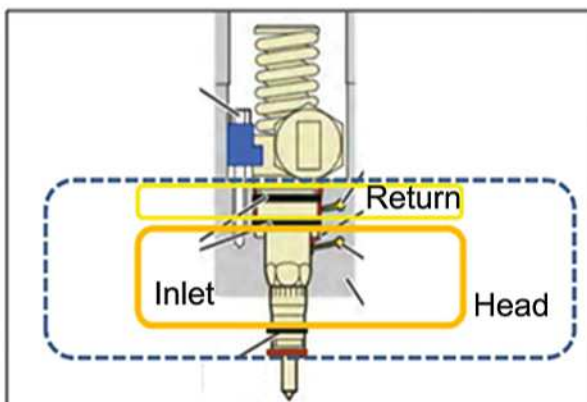
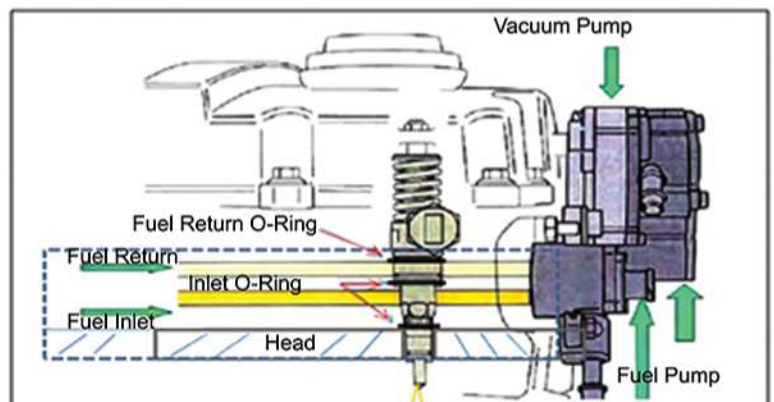
Sometimes oil mixes with diesel inside the tank. This problem is primarily caused by an excessive wearing of UIS injector o-rings, that cannot grant the proper sealing anymore and allow engine oil to leak into the diesel return circuit.

Oil mixed with diesel causes the fuel to become denser, and as a consequence the fuel pump works under excessive load when pushing fuel into the circuit.

An overloaded fuel pump has higher power absorption and lower performance. As a result, it produces **excessive noise**.
