Complaints about codes 76984, 76985, 77208 and 77209.

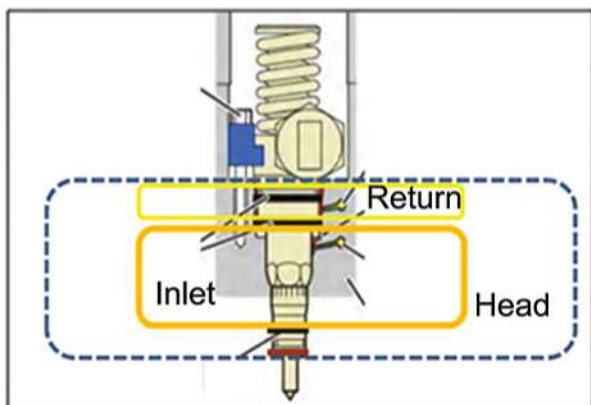
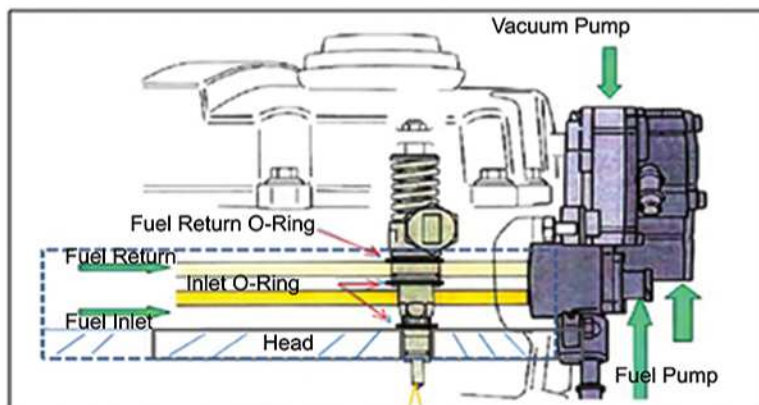
Sometimes oil mixes with diesel inside the tank. This problem is primarily caused by an excessive wearing of UIS injector o-rings, that cannot grant the proper sealing anymore and allow engine oil to leak into the diesel return circuit.

Oil mixed with diesel causes the fuel to become denser, and as a consequence the fuel pump works under excessive load when pushing fuel into the circuit.

An overloaded fuel pump has higher power absorption and lower performance. As a result, it produces **excessive noise**.
