Problems Concerning VAG Engines – Unit Injectors

Oil mixed with Diesel or Diesel mixed with Oil

Oil level increased in the carter: possible causes

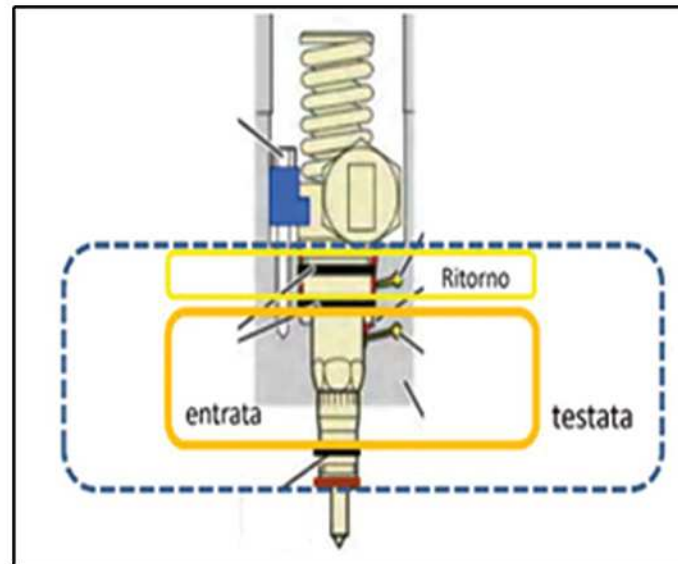
2) The second cause of diesel mixing with oil could come from missing steps of DPF regeneration, since the injector produces an excess of diesel that leaks through the piston rings into the carter.

All owners of VW models that mount this engine type are warned: in intense city and traffic use of the vehicle, interrupted regeneration cycles that happen very often under these driving conditions, could make the DPF filter to block and CAUSE DIESEL TO MIX WITH OIL. This means it is appropriate for longer engine life to check the oil level, in order to verify dangerous diesel contaminations into the oil circuit that may damage the whole engine.

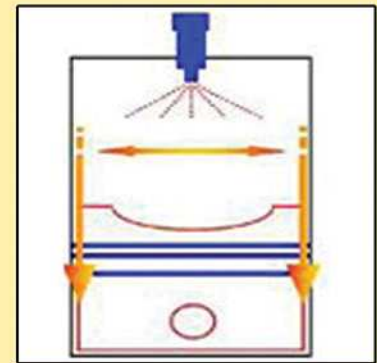
An extra fuel injection cycle (post injection) takes place when the piston is at bottom dead center and that allows a temperature increasing of exhaust gases at a fixed value of 600° C as the excess fuel amount is burned inside the outlet manifold (pre-catalyst and catalyst). This process generates diesel leaks into the oil carter.

When the engine activates Post injection (see photo on top) the fuel nebulization on cylinder walls causes an increase of fuel leaking into the oil carter.

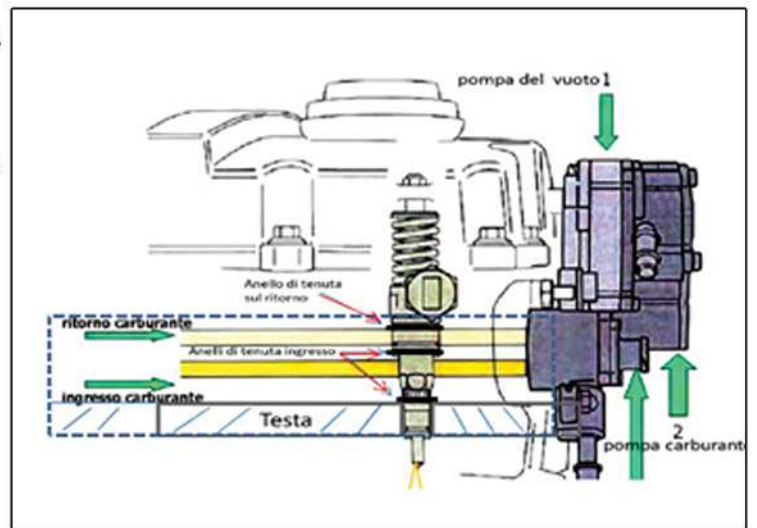
The vacuum pump is one of the critical places in which oil and diesel may mix.

In fact, the pump has two separate chambers. The first chamber is used to aspirate diesel and pump it to the unit injectors, while the second chamber creates vacuum. Both chambers share the same shaft.

For its proper functioning, both internal paddles and shaft are oil lubricated. If the internal gaskets, that separate the two chambers, lose their sealing oil and diesel will mix. In this case, there will also be other signs such as pressure loss and fumes in the exhaust.

N.B. loss of sealing between the two chambers of tandem pump (8091093) may occur due to bad lubrication due to low oil quantity or quality.
