Problems Concerning VAG Engines – Unit Injectors

Oil mixed with Diesel or Diesel mixed with Oil

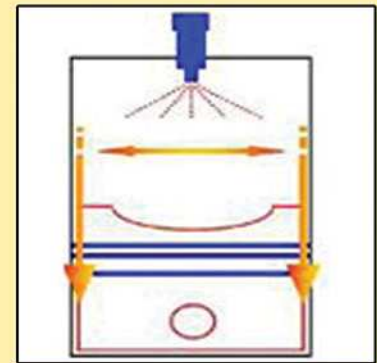
An extra fuel injection cycle (post injection) takes place when the piston is at bottom dead center and that allows a temperature increasing of exhaust gases at a fixed value of 600° C as the excess fuel amount is burned inside the outlet manifold (pre-catalyst and catalyst). This process generates diesel leaks into the oil carter.

When the engine activates Post injection (see photo on top) the fuel nebulization on cylinder walls causes an increase of fuel leaking into the oil carter.

The most immediate consequence is that the automatic DPF regeneration will start every 200 km or even less, instead of every 800 km. But the worst consequence is that the probability of stopping the regeneration after the vehicle is stopped will increase. As in every regeneration cycle a little amount of diesel leaks into the carter, the leak will be greater once the cycle is interrupted. Eventually, there will be some liters of diesel mixed with oil (this possibility may seriously damage the DPF filter and the engine).

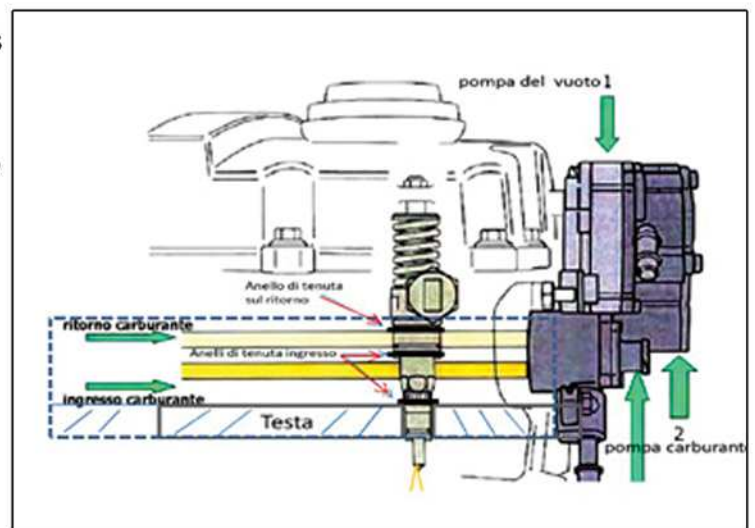
The vacuum pump is one of the critical places in which oil and diesel may mix.

In fact, the pump has two separate chambers. The first chamber is used to aspirate diesel and pump it to the unit injectors, while the second chamber creates vacuum. Both chambers share the same shaft.

For its proper functioning, both internal paddles and shaft are oil lubricated. If the internal gaskets, that separate the two chambers, lose their sealing oil and diesel will mix. In this case, there will also be other signs such as pressure loss and fumes in the exhaust.

When oil is found into the fuel, the most frequent causes are the O-rings that don't seal properly into the tandem pump.

N.B. loss of sealing between the two chambers of tandem pump (91093) may occur due to bad lubrication due to low oil quantity or quality.
