EGR VALVE - 7518117

Fiat Auto Service News

272- SCUDO 2.0 16V JTD T.T. Injection control unit – EGR electrovalve

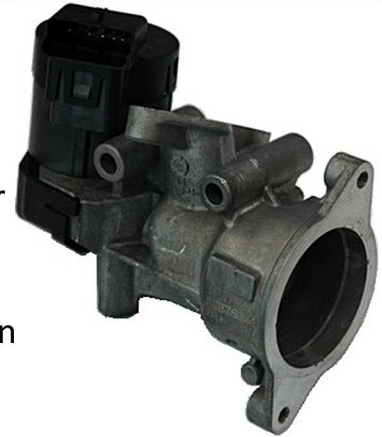
From FIAT's Servizio di Assistenza information below, it is clear that a plate breakage of the EGR valve is not due to a manufacturing defect of the same, (stem too thin or welding performed poorly), but due to external causes that have nothing to do with the product we provide.

Rupture of the EGR valve: in some cases, the plate of the valve, which is controlled to excessive speed by the control unit, is repeatedly beaten on its base eventually breaking away from the rod.

At the time of sale let the customer know that in addition to the replacement of the EGR there is an absolute need to update the Control unit in order to avoid incurring the same defect.

In the presence of complains and found fault replace the EGR valve and reprogram the injection control unit with the new software WEB Flash 8.20.5 (or higher) available from ExaminerWeb and wiTEXEDi.
