Rare problem found in supply units 7506531 and 7506532

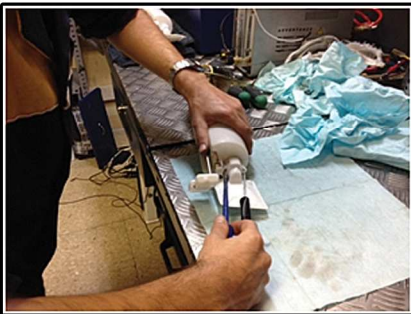
1. Remove the fuel filter

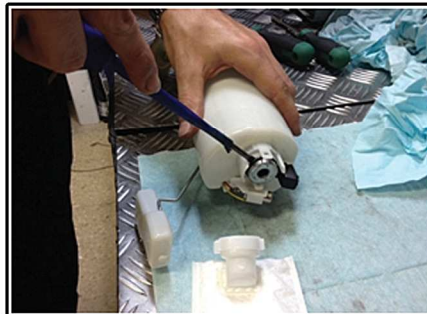
2. Remove the one way valve

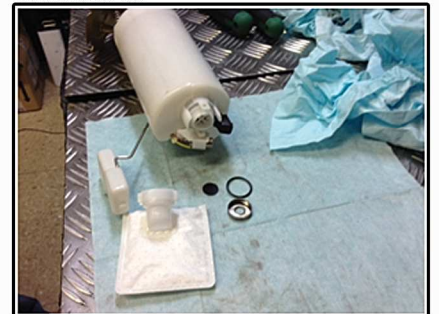
3. The one way valve as it appears dismantled

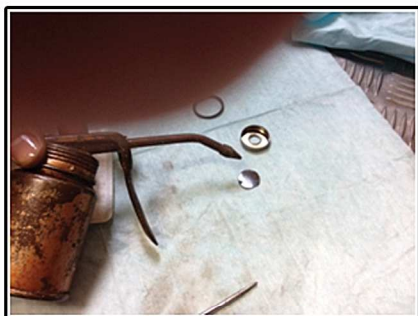
4. Lubricate the valve plate

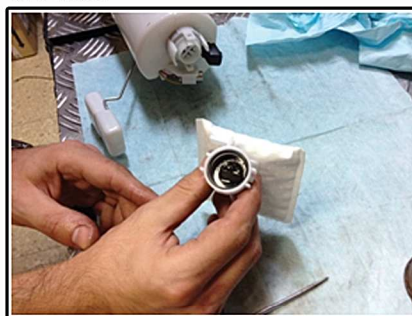
5. Reassemble the valve inside the filter

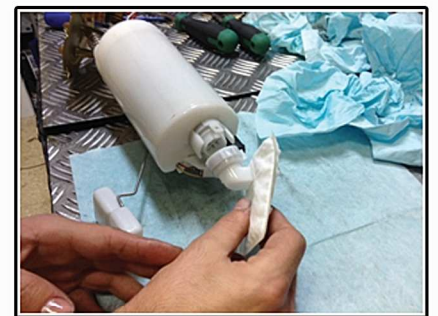
6. Reinstall the fuel filter
